# Installation & User Guide

High definition RGBHV receive units with automatic EQ

- models covered: RAM-300, RAM-300A, RAM-300A-RS, RAM-300A-2RS

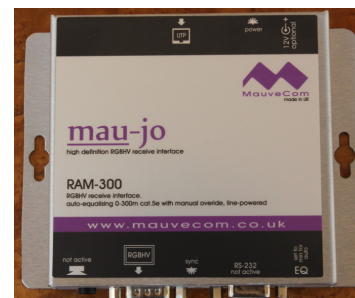
The RAM-300 range is typically ine-powered via the cat.5 cable but can also be powered directly. In this mode, the far-end Tx unit can be powered from

the UTP. Never connect a PSU rated more than 12V. Never use an unregulated PSU.
